RESEARCH REPORT

MOLDS IN FINISHED BASEMENTS

FINAL REPORT

Scanada Consultants Limited
436 MacLaren Street
Ottawa, Ontario
K2P 0M8

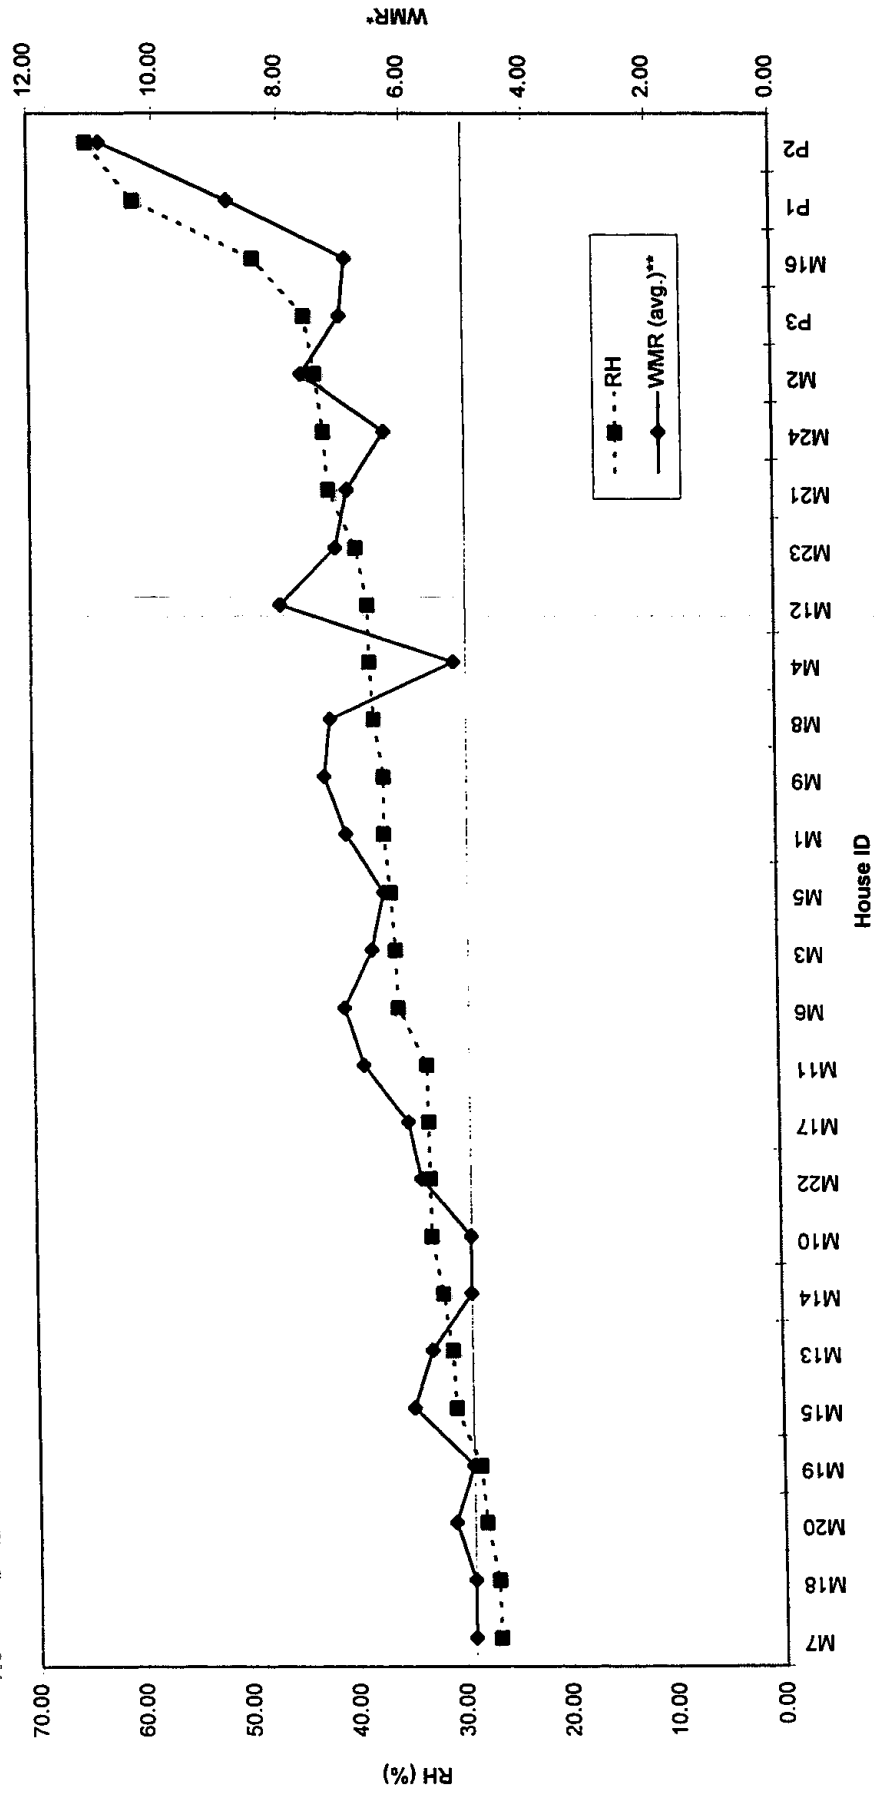
Figure 1. Wood Moisture Readings versus Long Term Relative Humidity

Five wood moisture meter readings were taken in each basement to see if a correlation could be made with the measured relative humidity in the room. As shown in Figure 1, the correlation between the average wood moisture meter readings and the relative humidities is demonstrated.
